# Reflective Crack Mitigation Guide for Flexible Pavements Final Report

# Reflective Crack Mitigation Guide for Flexible Pavements

**Final Report**  
**September 2015**

**Sponsored by**  
Iowa Highway Research Board  
(IHRB Project TR-641)  
Iowa Department of Transportation  
(InTrans Project 11-424)

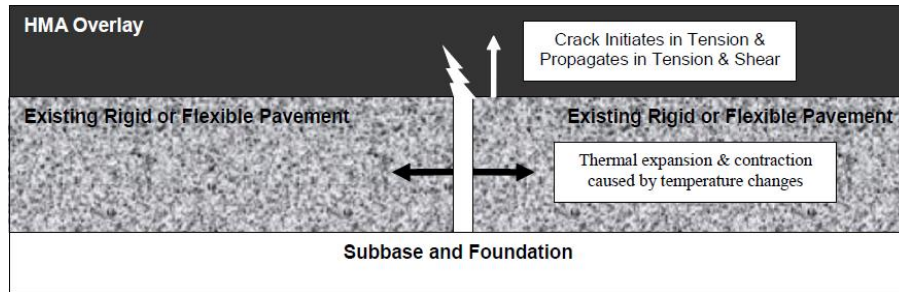
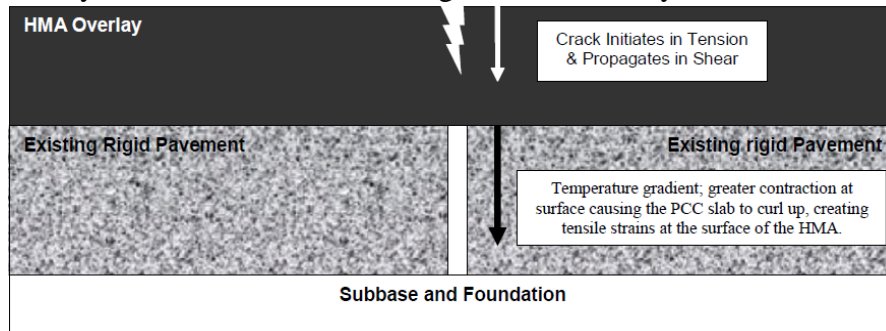
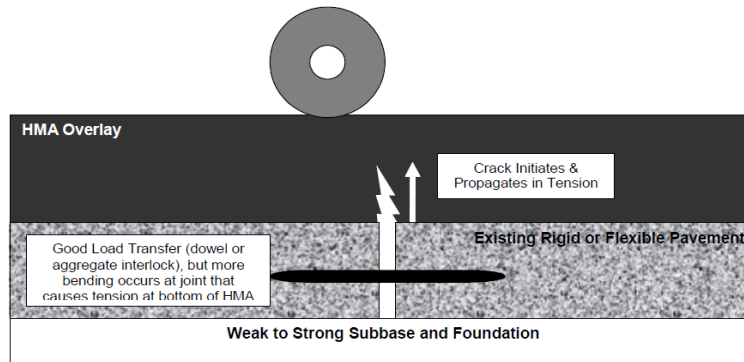
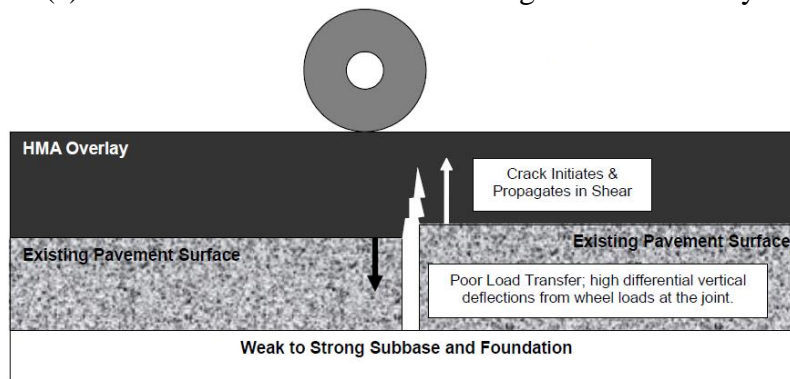
**Figure 1. Mechanisms of reflective cracking of HMA overlays**

Reflective cracks propagate through the HMA overlay surface due to the movement at the crack (joint in case of existing concrete pavements) producing tensile stresses which are caused by (a) discontinuities in the underlying layers, (b) differential temperature conditions, and (c) longitudinal cracks in the old surface (Roberts et al. 1996). Schematic diagrams of thermally-induced and traffic-induced reflective cracking mechanisms are shown in Figure 1 (Von Quintus et al. 2009).

(a) Thermally-induced reflective cracking of HMA overlays: horizontal movements

(b) Thermally-induced reflective cracking of HMA overlays: curling of PCC slab

(c) Traffic-induced reflective cracking of HMA overlays

(d) Traffic-induced reflective cracking of HMA overlays

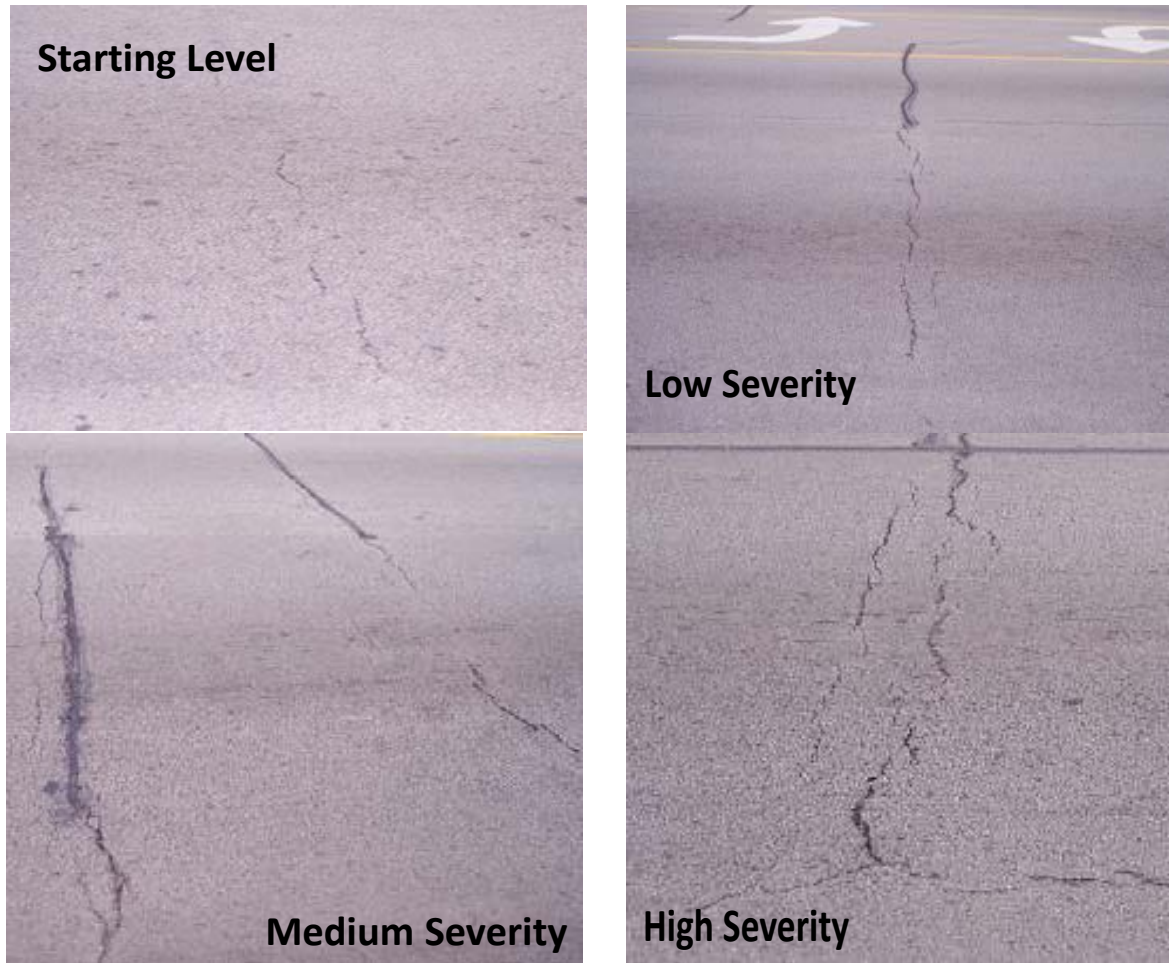
**Figure 2. Reflective cracking severity levels**

The combined effect of traffic and environmental loadings is considered to cause reflective cracks which can initiate either at the top or bottom of the HMA overlays. The rate of propagation of the reflective cracks is dependent on a number of factors including the thickness of the overlay, properties of the HMA overlay, type of reinforcement (if used), and the subgrade condition (Von Quintus et al. 2009). Reflective cracks observed in HMA overlays at different levels of severity are shown in Figure 2 (Al-Qadi et al. 2009).

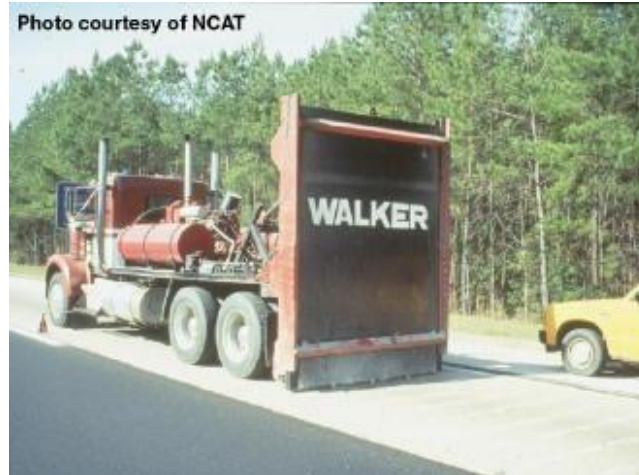
Four major steps are involved in implementing crack and seat techniques (see Figure 3): cracking the concrete slab (using a drop hammer or guillotine or modified pile driver or whip hammer), seating the cracked slab, applying special treatments, and placing the HMA overlay.

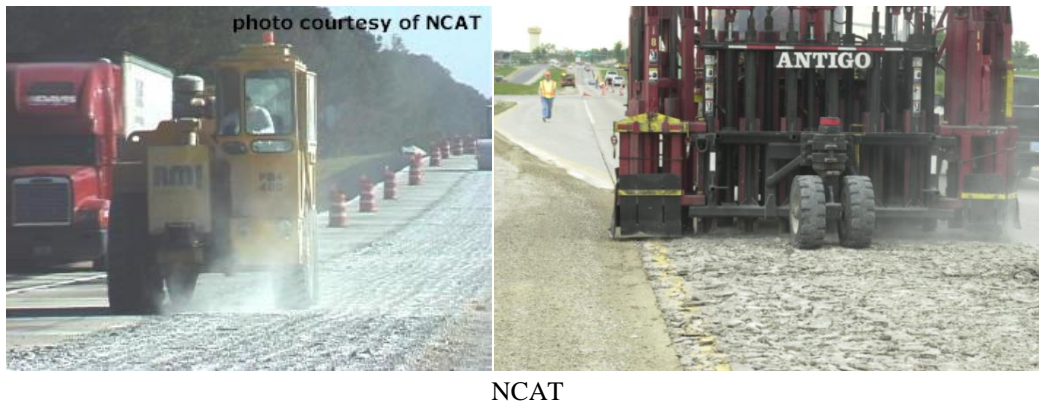
In general, two types of equipment are used in the rubblization process (see Figure 4): resonant pavement breaker (RPB) and multiple-head breaker (MHB).

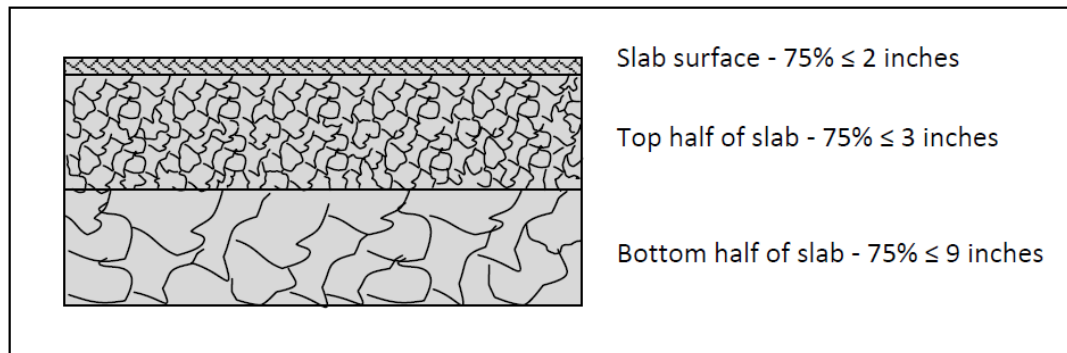
To address the various construction challenges when implementing this strategy, in February 2004 the FAA adopted and published FAA Engineering Brief (EB) No. 66, *Rubblized Portland Cement Concrete Base Course*. The document includes guidance and criterion for rubblizing PCC pavements. Similarly, the Wisconsin Department of Transportation (WisDOT) Standard Specifications give guidance to the contractors with respect to size requirements for rubblized pieces in slab surface, top half of slab, and bottom half of slab as shown in Figure 5.

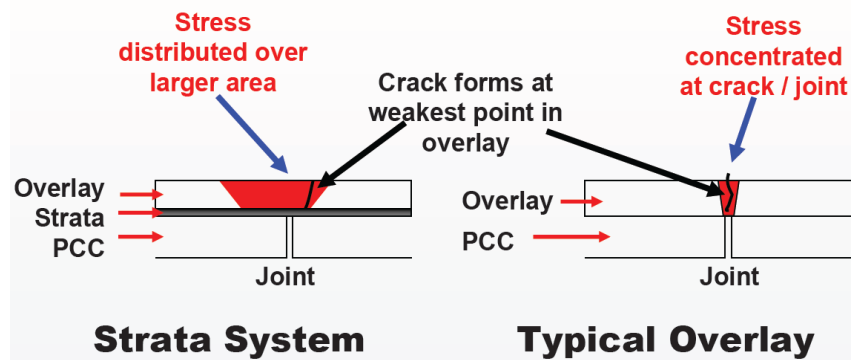
Strata is a reflective crack relief system promoted by SEM Materials, Inc. (now Road Science LLC, a division of ArrMaz Custom Chemicals) that protects the existing pavement structure from water damage and delays reflective cracks. According to Road Science LLC, the Strata system has several advantages: it significantly delays reflective cracking longer than paving fabrics and HMA overlays; it provides an impermeable interlayer to protect pavement structure from moisture damage; it provides a highly fatigue resistant material; it uses readily available aggregates and it lengthens pavement service life; it provides ease of mixing, placement, and compaction through the use of conventional HMA paving equipment and standard construction methods; and it provides savings in construction time and facilitating easy maintenance of pavement (Von Quintus et al. 2009). See Figure 7.

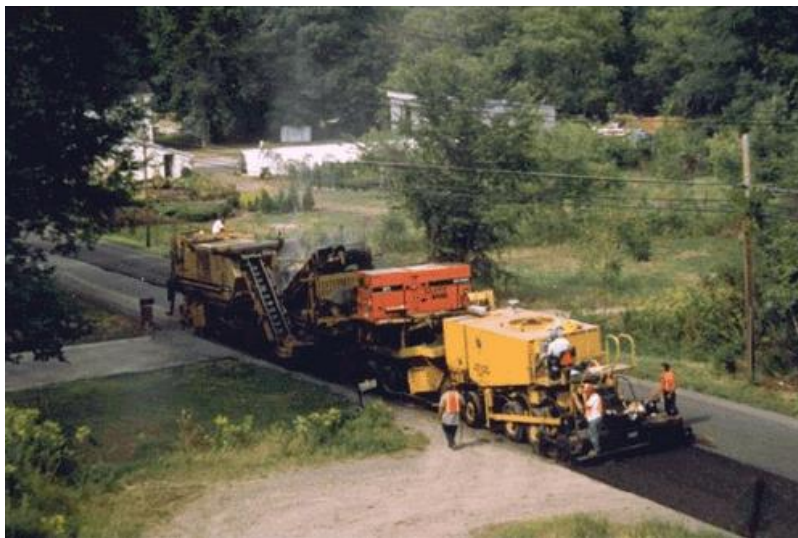
FDR and CIR are viable strategies to remove cracks in HMA pavements. CIR involves cold milling the existing HMA surface; mixing the cold milled materials with emulsified asphalt or other modifiers to improve the properties of original HMA mix; and screeding, spreading, and compacting the recycled mixture in one continuous operation (see Figure 9).

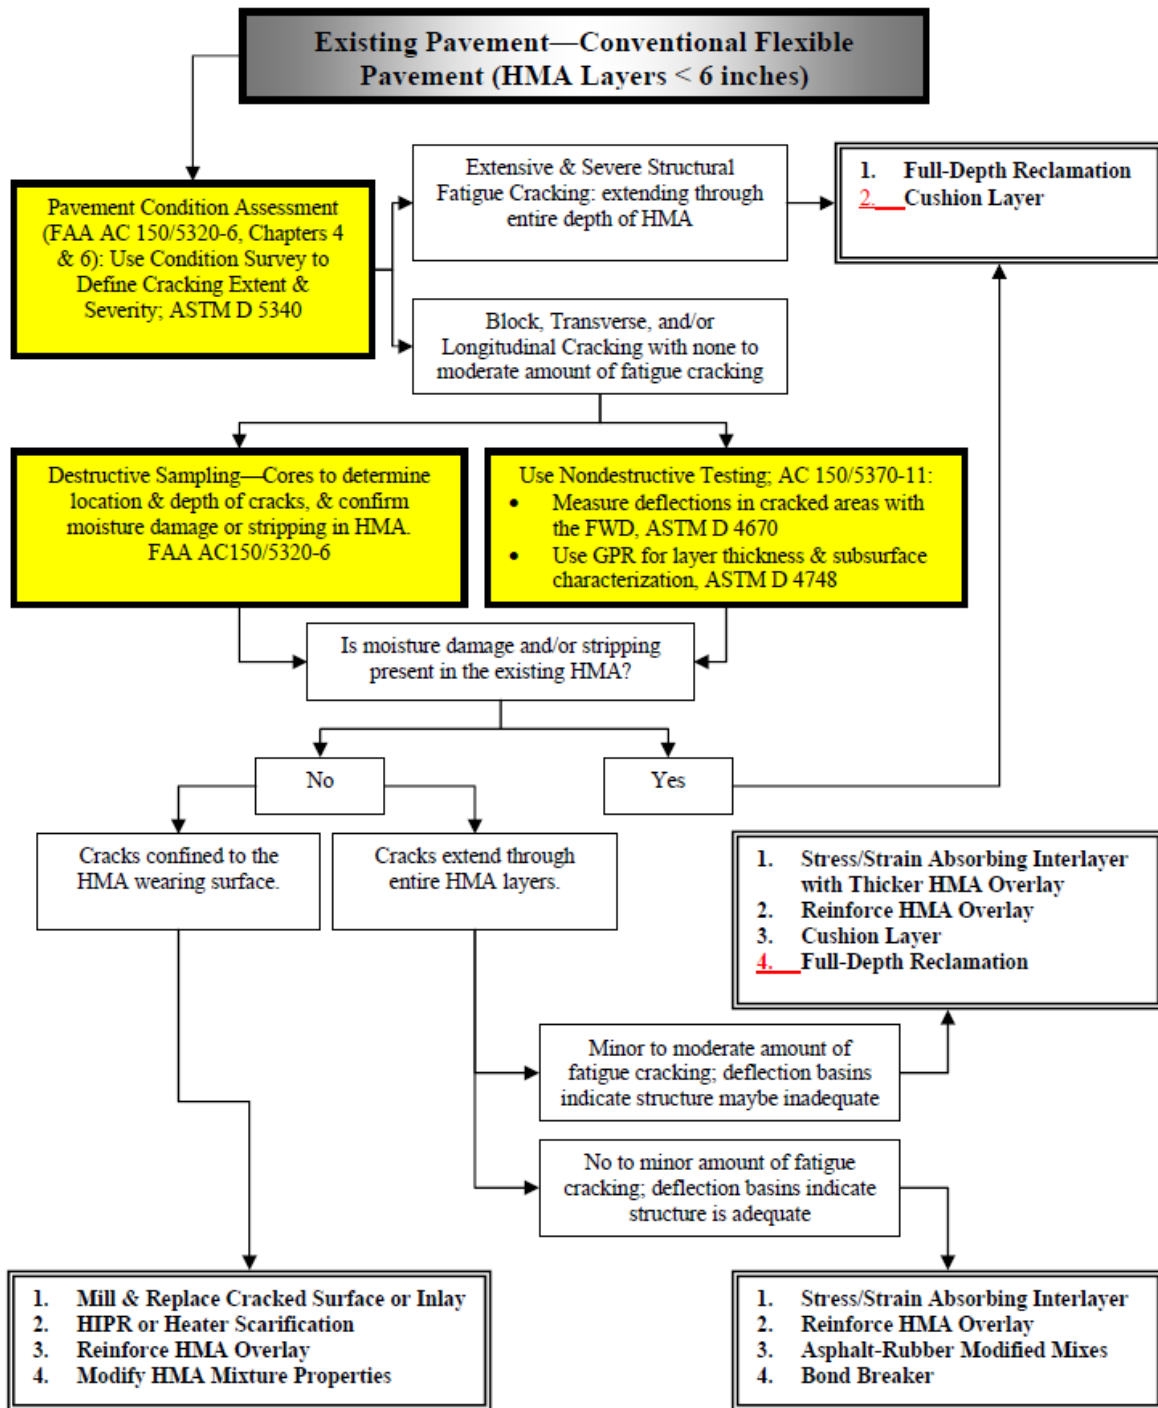
Von Quintus et al. (2009) reviewed products and processes that have been used to mitigate reflective cracks in rigid and flexible airport pavements. Decision trees providing guidance to select the appropriate mitigation treatment method for the site and in place pavement condition was developed (see Figure 11 and Figure 12). Similar decision trees would be greatly beneficial to Iowa design engineers when selecting a reflective cracking mitigation strategy for a particular project.

**Figure 11. Decision tree for providing guidance reflective cracking mitigation in HMA overlays of existing conventional flexible airport pavements**

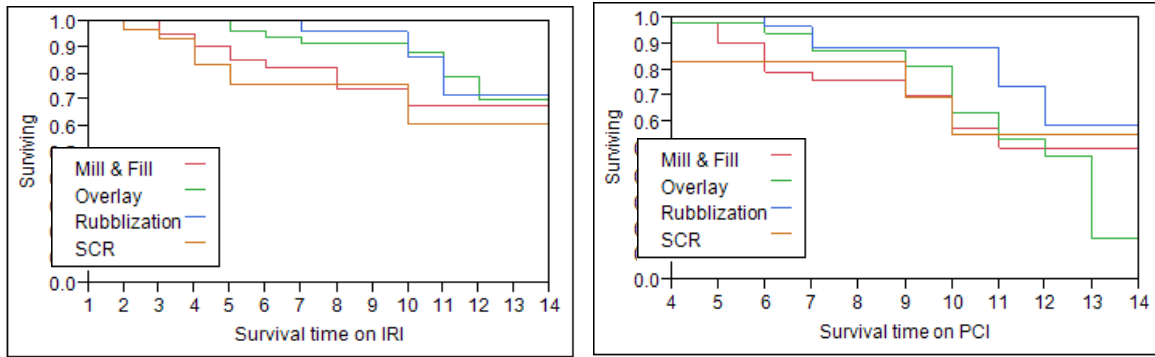
Figure 15 illustrates the relationship between survival function and pavement service life based on IRI and PCI.

**Figure 15. Kaplan-Meier estimator curves for IRI and PCI**

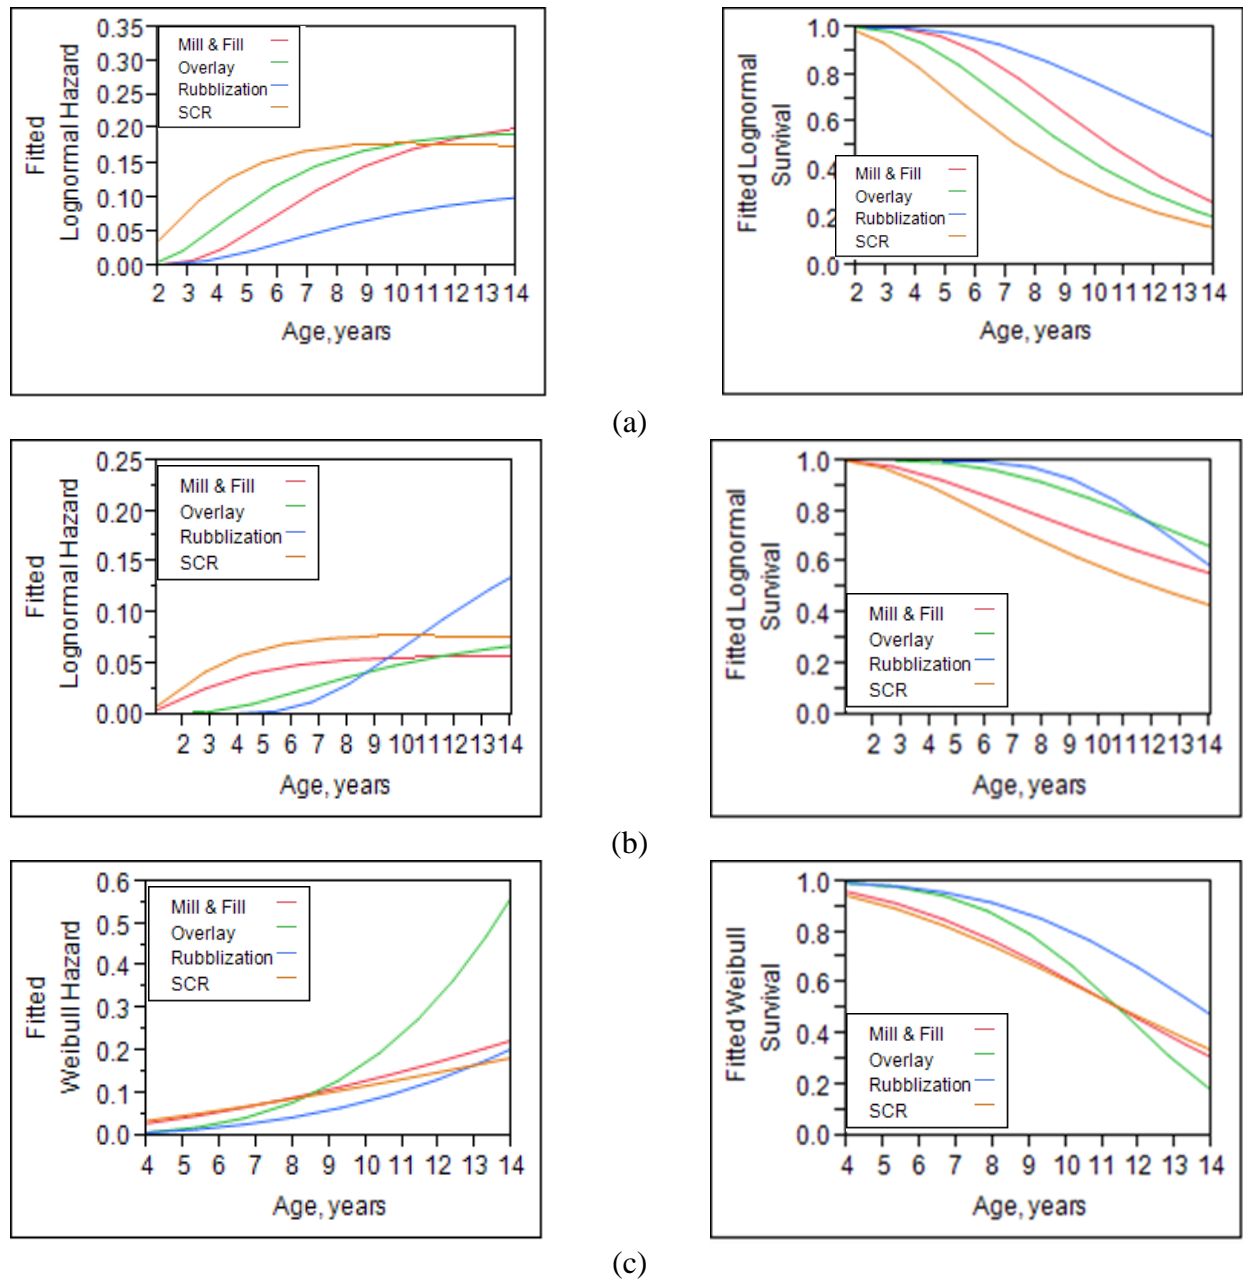
Further, the modeled hazard and survival functions are presented in Figure 16 for the three pavement condition indicators.

**Figure 16. Summary of model fitted hazard and survival functions for (a) reflective cracking, (b) IRI, and (c) PCI**

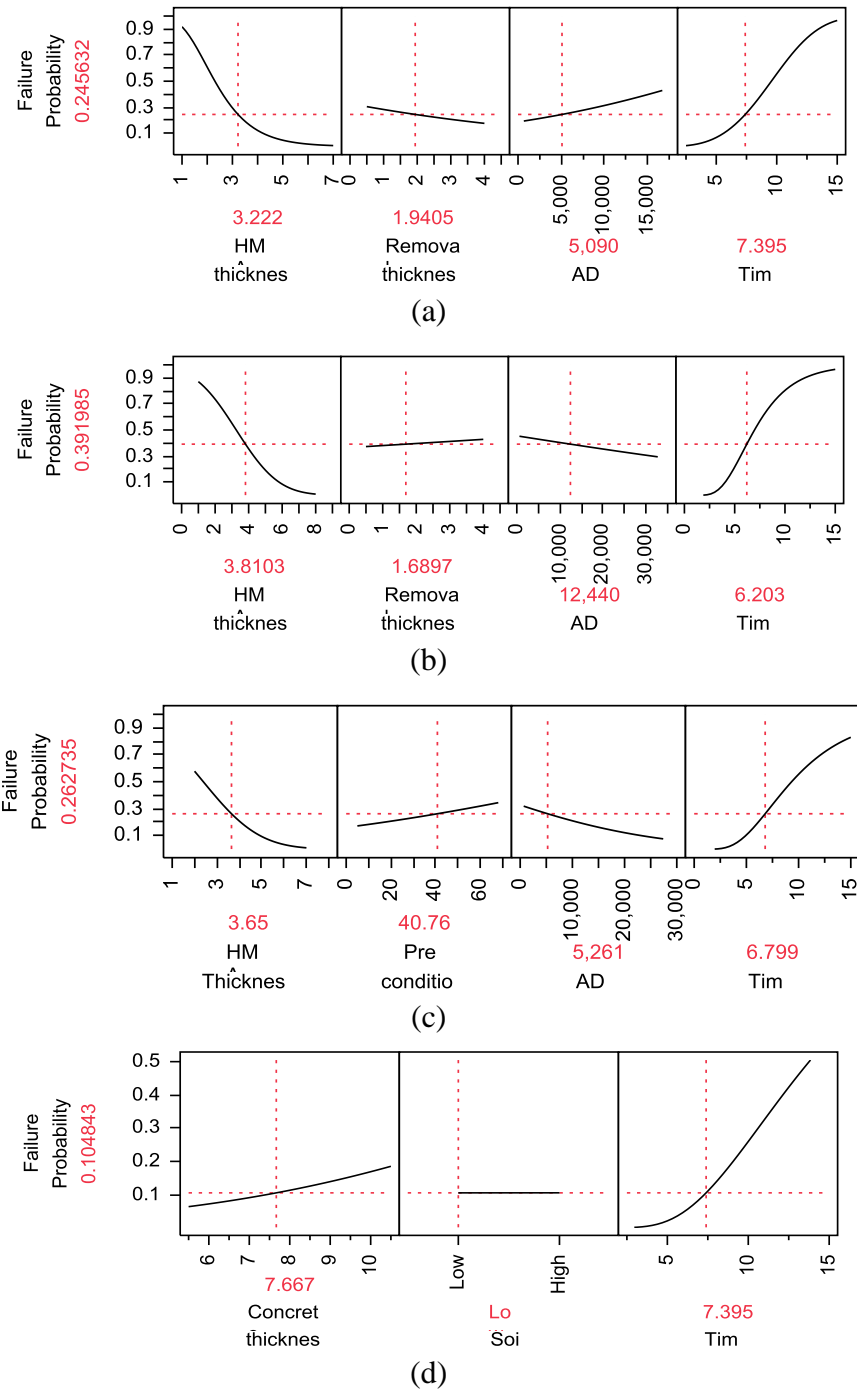
The selected models may differ from those used in the univariate analysis due to the influence of the additional covariates. The likelihood ratio test results shown in Table 6 determine the significance of each covariate by comparing the log-likelihood from the fitted models. The significance level is 0.05 for this test, and corresponds to a 95 percent level of confidence. Figure 18 displays the failure function profiler for the four rehabilitation methods.

**Figure 18. Influence factors on reflective cracking for (a) mill and fill, (b) SCR, (c) overlay, and (d) rubblization**

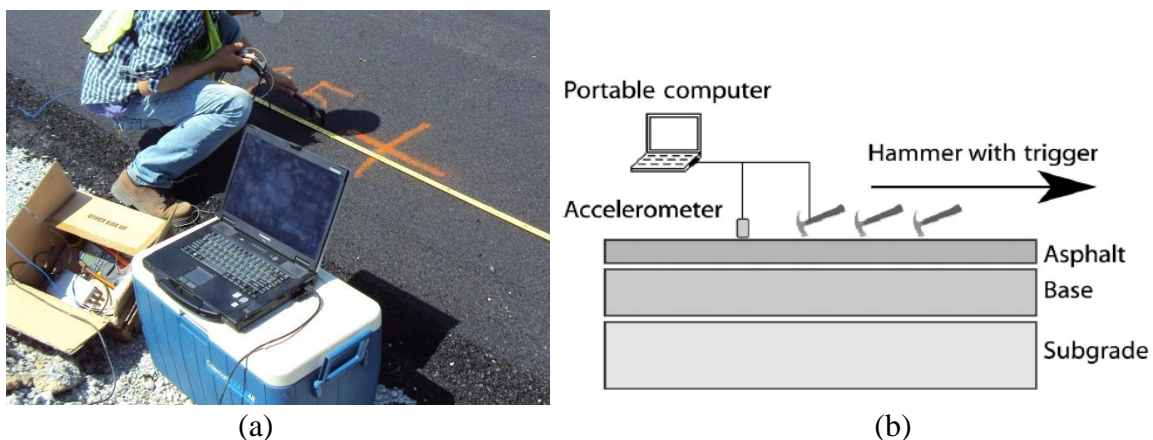
To measure the pavement structural modulus with the four types of treatments, nondestructive FWD and SWM testing were conducted. FWD Deflection data were collected using the JILS-20 FWD equipment by applying a step loading sequence of 9 kips at each testing location. Appendix B presents FWD surface deflections in each test section. Different from the large strain/high deflection measurement by the FWD testing, moduli obtained from the SWM testing are usually in very low strain range. Appendix C provides plots of SWM dispersion curves collected in this study. The use of SWM for nondestructive testing of pavements is not new, and its field applications become more popular after the appearance of modern spectral analyzers and powerful microcomputer (e.g., Nazarian 1984, Park et al. 1998, Ryden et al. 2002, Lin and Ashlock 2011, Lin and Ashlock 2014). Surface wave testing in this study was carried out using the multichannel simulation with one receiver (MSOR) testing system developed by Lin and Ashlock (2011, 2014). The set-up of the equipment for testing is shown in Figure 19 (a).

**Figure 19. Set-up of (a) surface wave equipment and (b) portable seismic acquisition system**

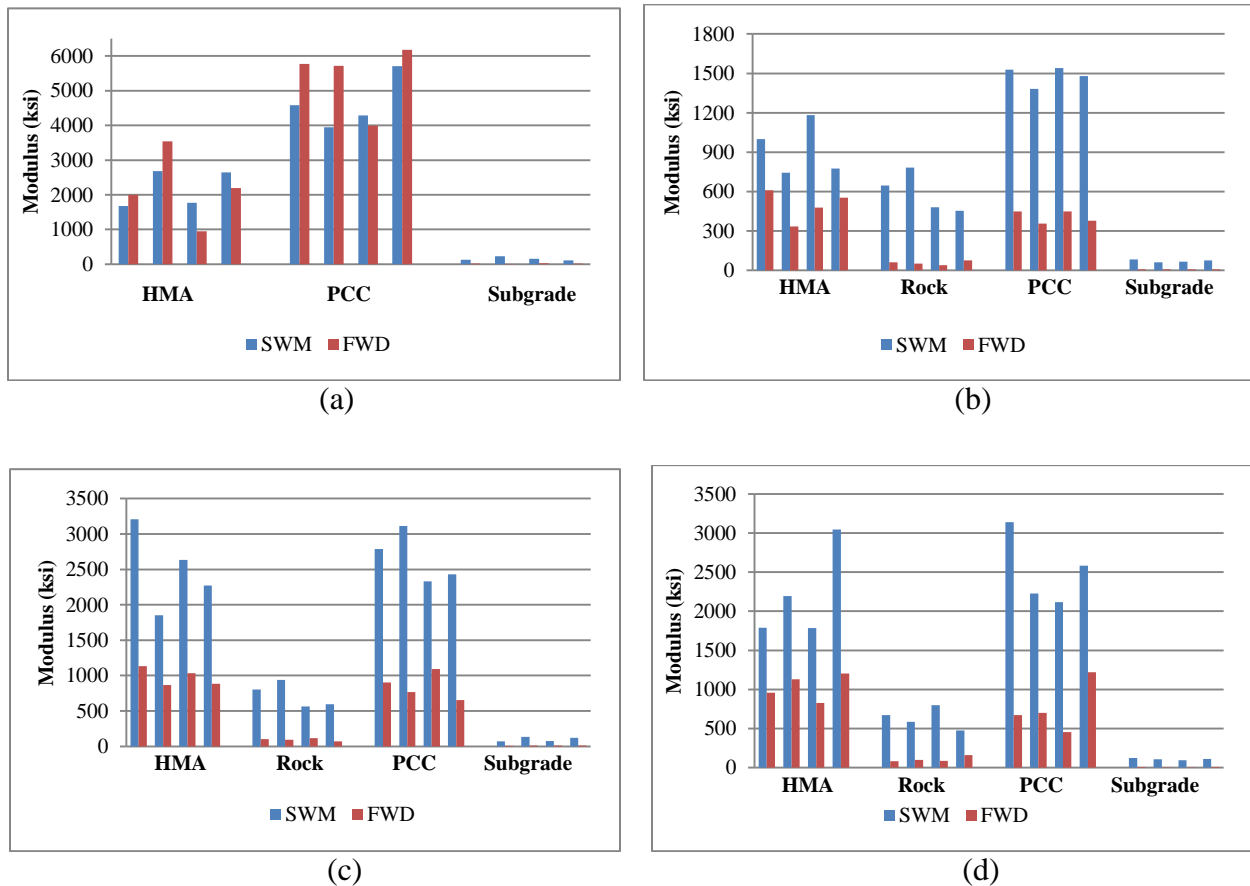
In the first four pavement sites, modulus value for each pavement layer and underlying subgrade were measured by both the FWD and SWM for a preliminary analysis. It is intended to examine the comparability and accuracy of the measured moduli by the two methods. Temperature adjustment was not considered for the FWD and SWM moduli since the tests were performed at the same location and time in one day. The moduli values for all four test sections are shown in Figure 20.

**Figure 20. Comparison of FWD and SWM results for (a) D43 project, (b) P59 project, (c), P29 North project, and (d) P29 South project**

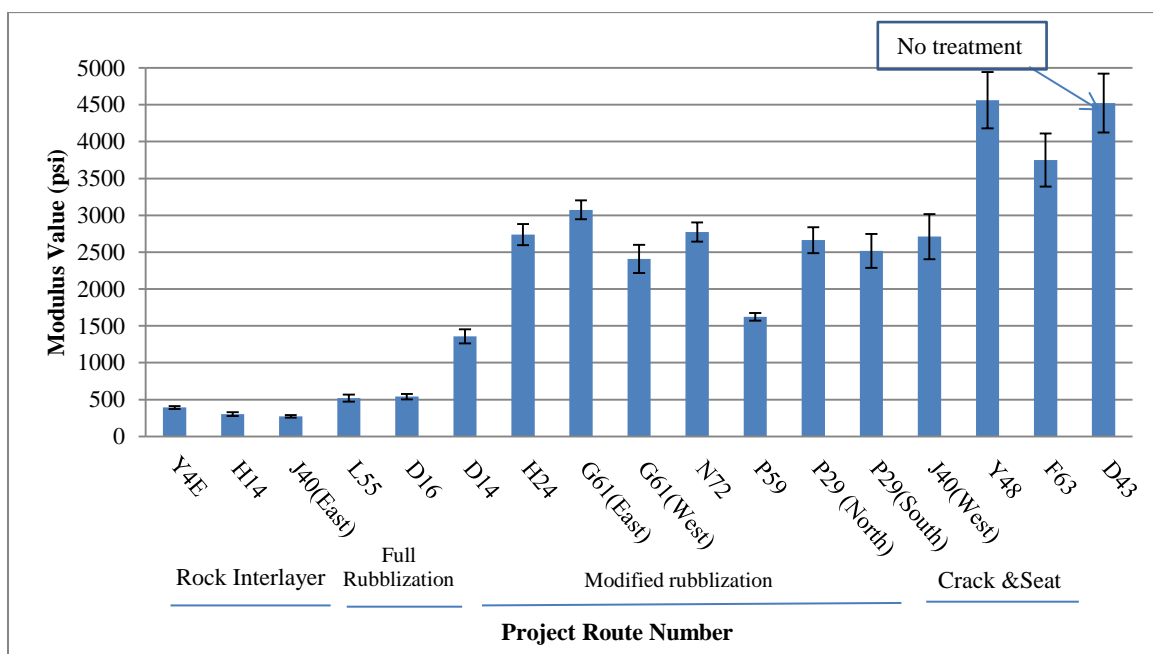
Figure 21 shows the average PCC layer and the rock interlayer moduli measured by the SWM in all 16 projects.

**Figure 21. Mean modulus value for each project**

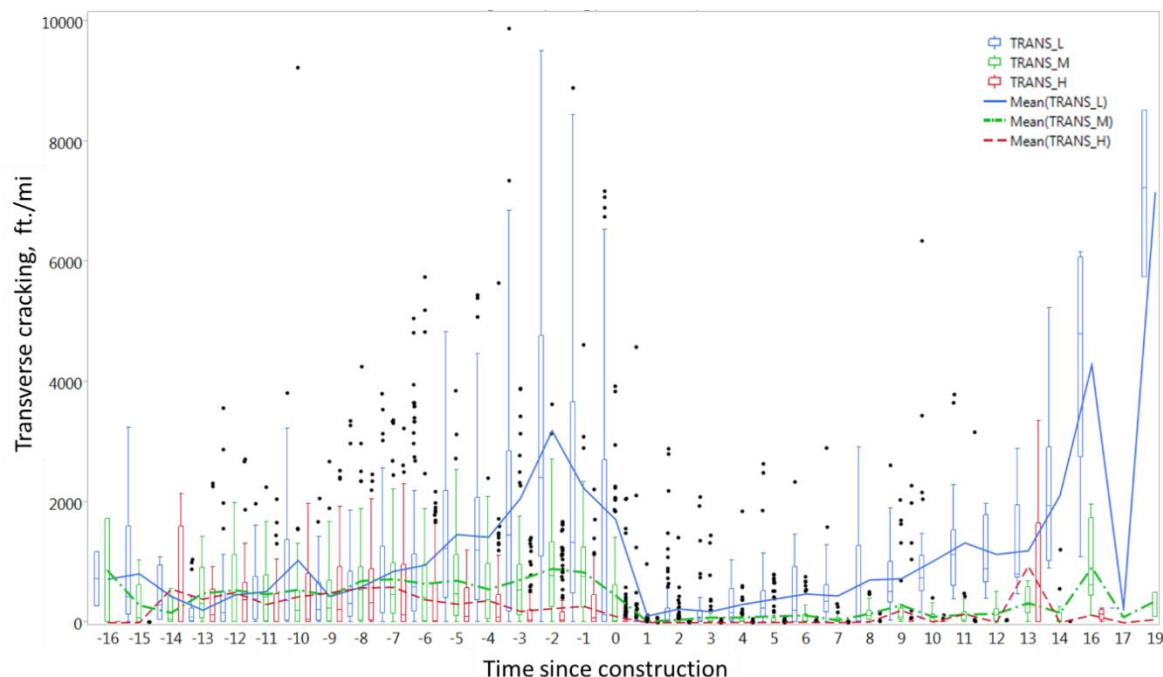
Iowa pavements are susceptible to transverse cracking because of large variations in temperature and very cold temperatures. Transverse cracking can also appear in the form of reflective cracking from joints in PCC pavement deeper in the pavement structure (Huang 2004). The transverse cracking in the CIR sections are shown in Figure 27.

**Figure 27. Transverse cracking before and after CIR rehabilitation**

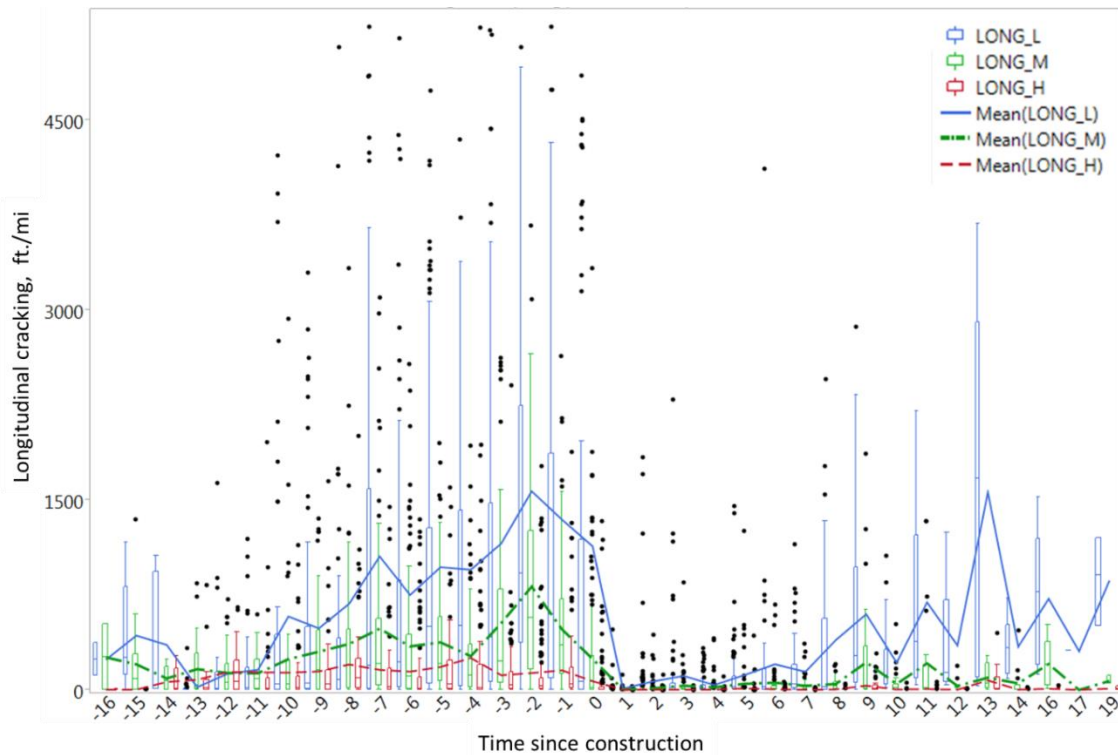
There are two types of longitudinal cracking measured in the PMIS, wheel path and non-wheel path longitudinal cracking. Figure 28 displays the longitudinal cracking for the non-wheel path cracking and shows that the average longitudinal cracks are reduced for some time after rehabilitation and high and medium severity cracks remain low throughout the analysis period.

**Figure 28. High, medium, and low severity non-wheel path longitudinal cracking**

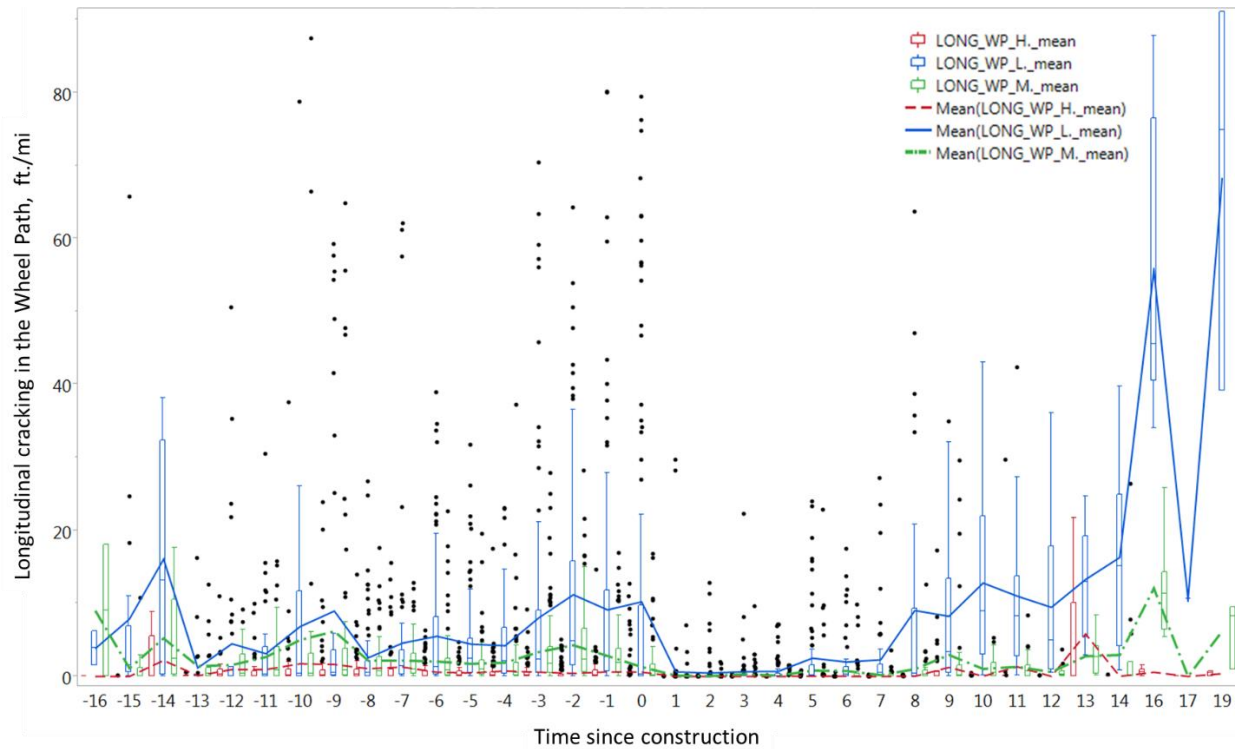
This is an indication that fatigue cracking will be low also. There is a slow increase in the longitudinal cracking but the averages shown for longer post-construction observations represent fewer projects. This limits the ability for global conclusions but the data shows an overall improvement in longitudinal cracking. The longitudinal cracking measured in the wheel path is shown in Figure 29.

**Figure 29. High, medium, and low severity longitudinal cracking in wheel path**

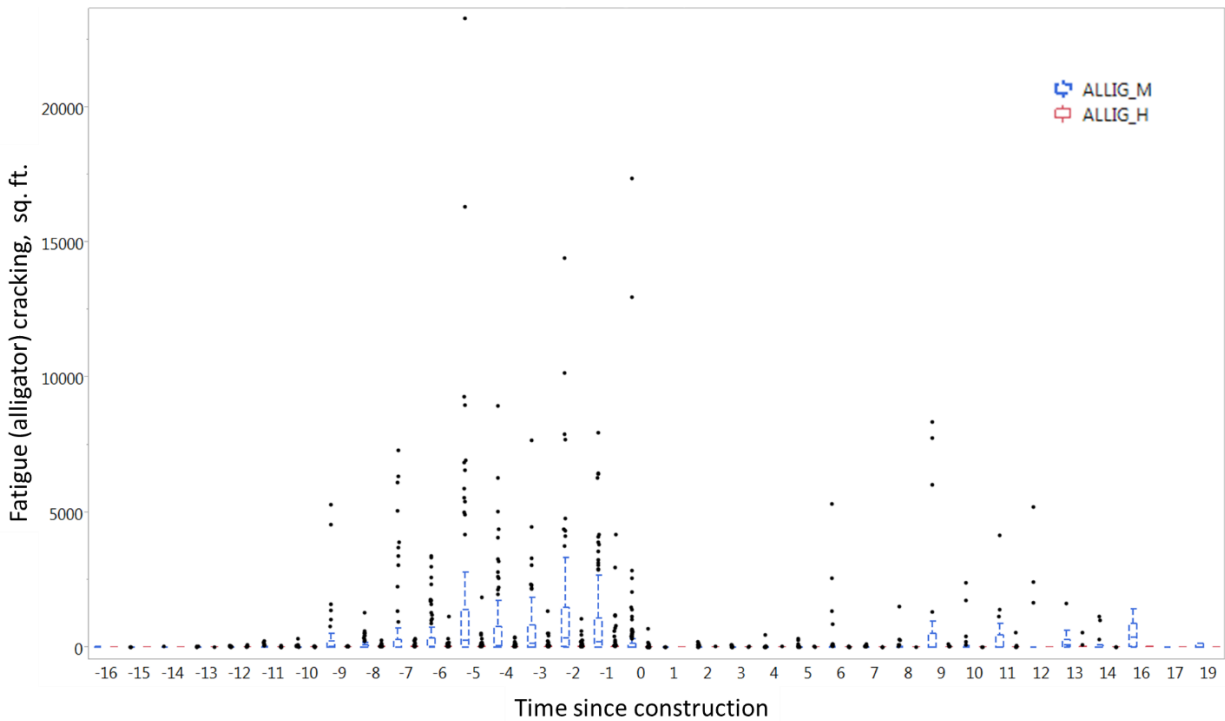
Fatigue cracking, also called alligator cracking is a load related distress and thus, does not typically occur until the pavement has been loaded many times. The cracking is generally slow to develop but begins to increase rapidly as the pavement weakens. The cracks usually begin as longitudinal parallel cracks but after repeated loading, form a series of interconnecting cracks that resemble the skin of an alligator (Huang 2004). The fatigue cracking is categorized as medium and high severity in the PMIS system. The fatigue cracking of the monitored pavement sections is shown in Figure 30.

**Figure 30. High and medium severity fatigue (alligator) cracking**

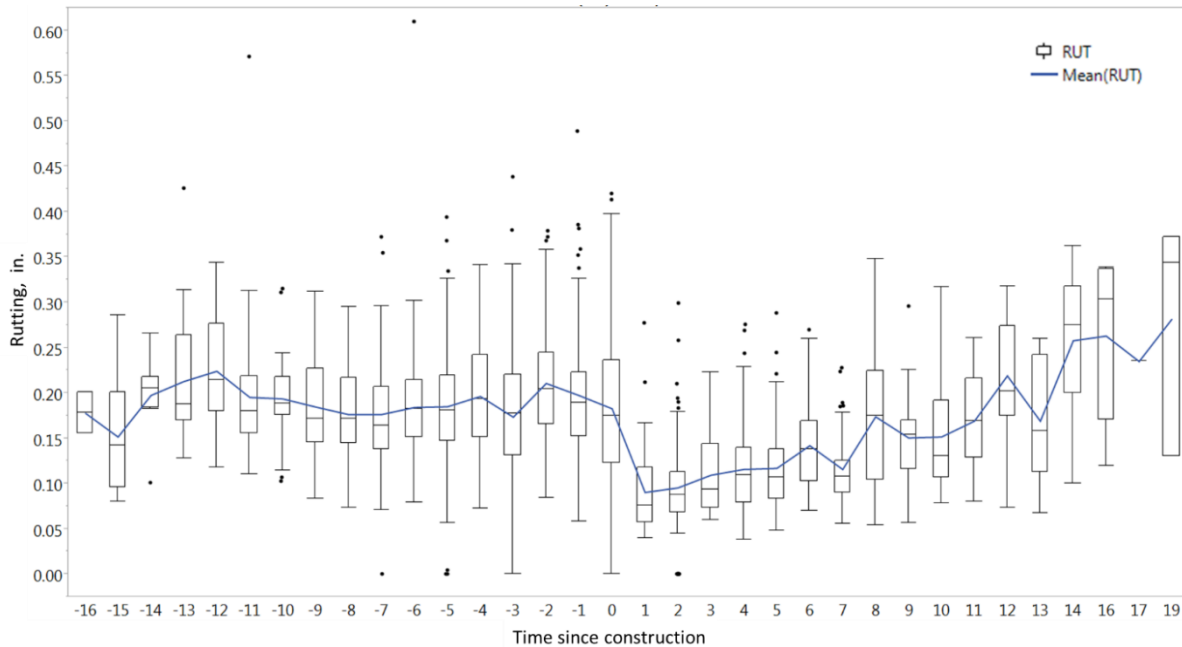
Rutting is defined as a longitudinal surface depression in the wheel path. It may have associated transverse displacement. Rutting can be a safety issue because it may prevent adequate drainage of water in the wheel path. Rutting can occur when any of the pavement layers, including the subgrade, consolidate or lateral movement of the material occurs. Rutting can also be caused by plastic movement of the asphalt mix due to inadequate compaction during construction or hot weather (Huang 2004). The rutting depth for each pavement section was measured and reported in Figure 31.

**Figure 31. Measured rutting of pavement with time**

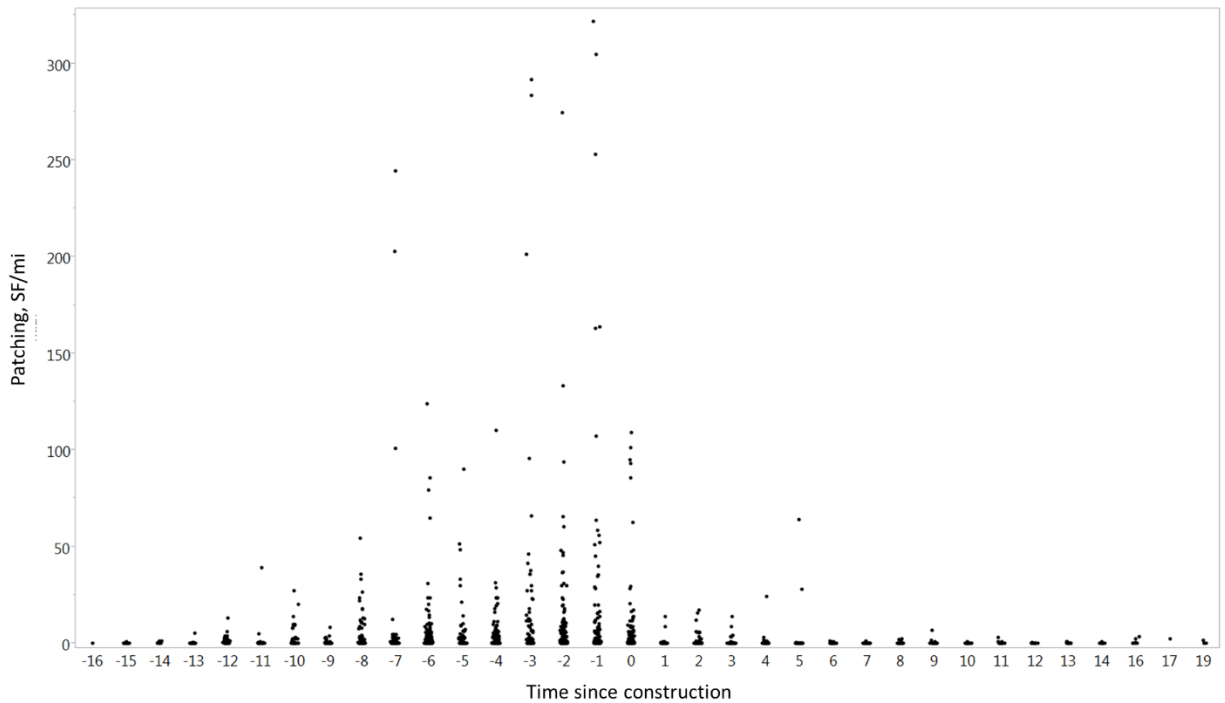
Patching is defined as a portion of the pavement surface, greater than  $0.1 \text{ m}^2$ , that has been removed and replaced or additional material applied to the pavement after original construction (Miller and Bellinger 2003). In the PMIS database, patching is measured in square feet per mile. Figure 32 shows the square feet of patching after the CIR rehabilitation, the square feet of patching required is markedly lower.

**Figure 32. Square feet of patching versus time**

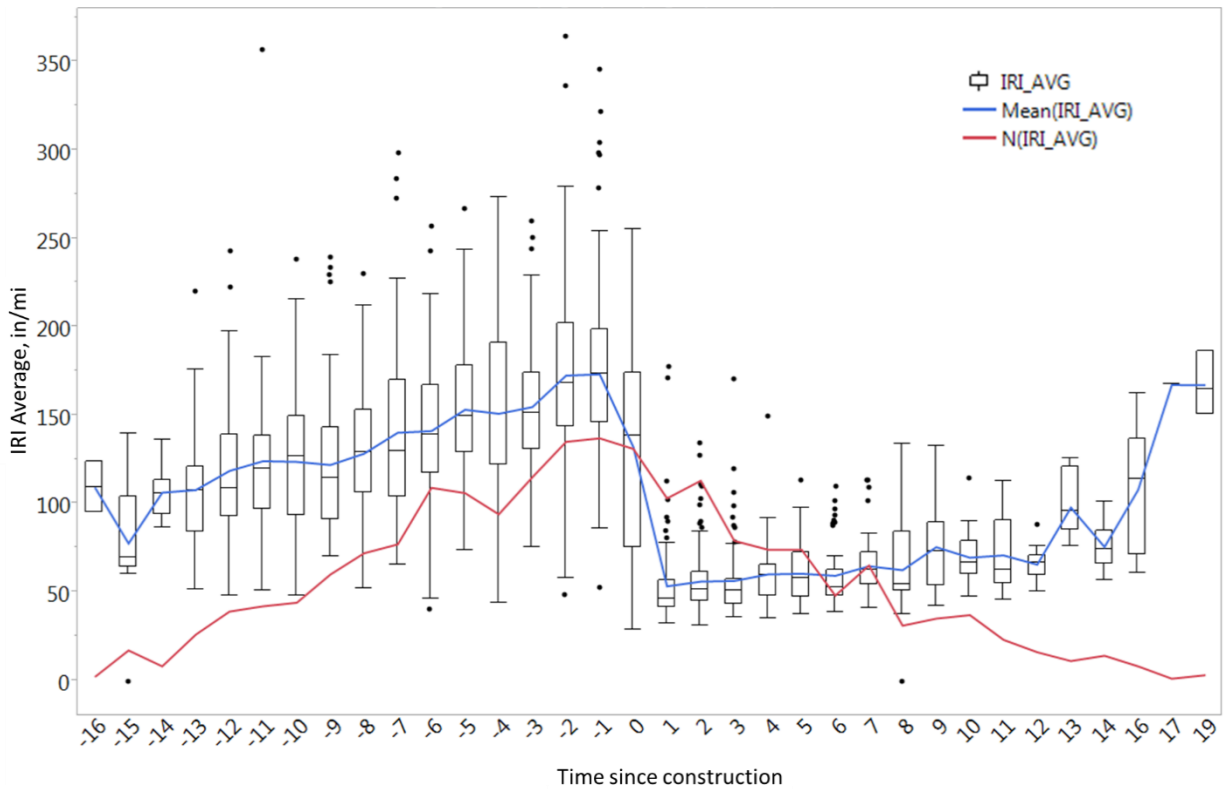
IRI summarizes the longitudinal surface profile in the wheel path and is computed from surface elevation data (Huang 2004). The higher values indicate higher roughness in the pavement. Table 1 in this report documents the IRI trigger value for various levels of roadways. The average IRI for each pavement is shown in Figure 33 and the number of projects measured for each year is indicated by the red line.

**Figure 33. Average IRI with box plot and red line indicating the number of projects monitored**

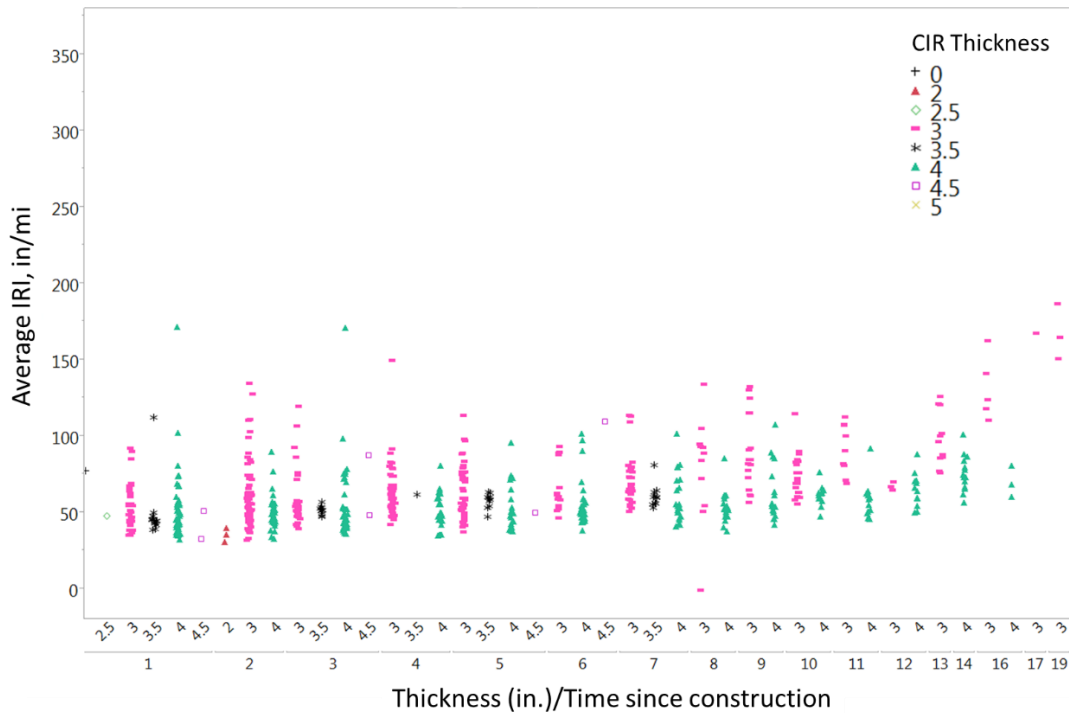
The IRI shows a steady increase in roughness until the time of rehabilitation. The IRI of the rehabilitated pavement shows a slow but steady increase over time. The IRI values from years 13 to 19 post-construction represent only a small percentage of rehabilitated pavements and these values should not be interpreted as an exponential increase in IRI. A factor that appears to influence the long-term IRI of the pavement is the thickness of the CIR layer. Figure 34 shows the IRI for each section categorized by thickness.

**Figure 34. Average IRI by thickness and time in years since construction**

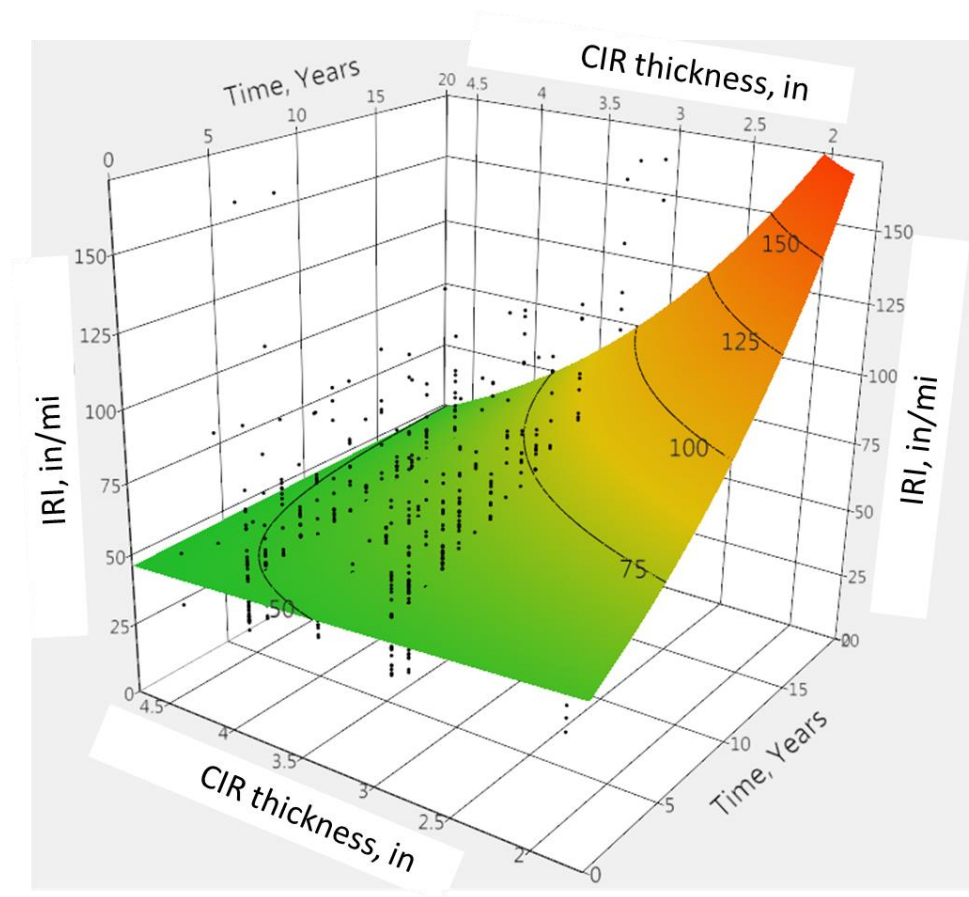
Since thickness appeared to be a significant factor in the IRI performance, a multiple regression model was developed using CIR thickness, interlayer thickness and surface thickness as a function of time to determine the IRI values. This model can be improved in the future as more data becomes available, especially for longer post-construction durations and low CIR thicknesses. The model was developed using a natural log transformation to ensure the rule of equal variance was met. The model results are shown in Figure 35 with the measured data points.

**Figure 35. Predicted IRI as a function of CIR thickness and time shown with actual data points**

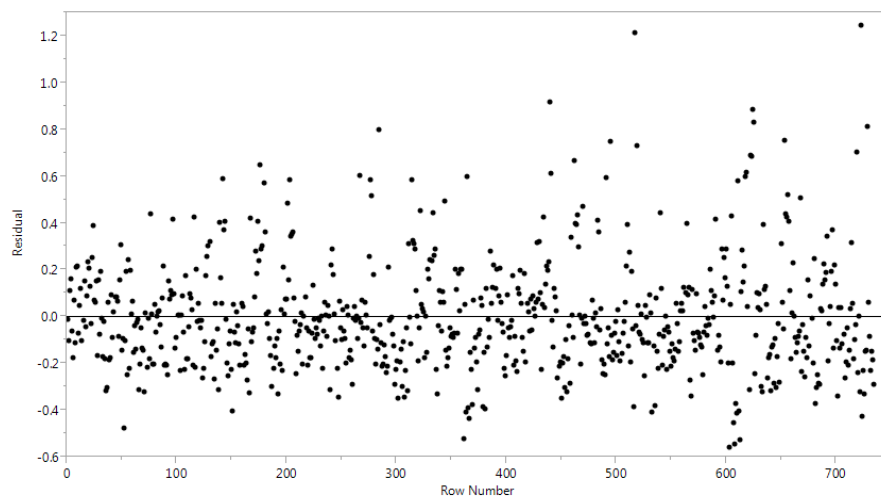
To see if a model is over or under estimating, a plot of the residuals can be examined as shown in Figure 36.

**Figure 36. Plot of residuals by row number**
